Subject: **Roof Survey Report**  
**Union County Civic Center**  
**165 Wellborn Street**  
**Blairsville, Georgia 30512**

Survey Date: January 30, 2016

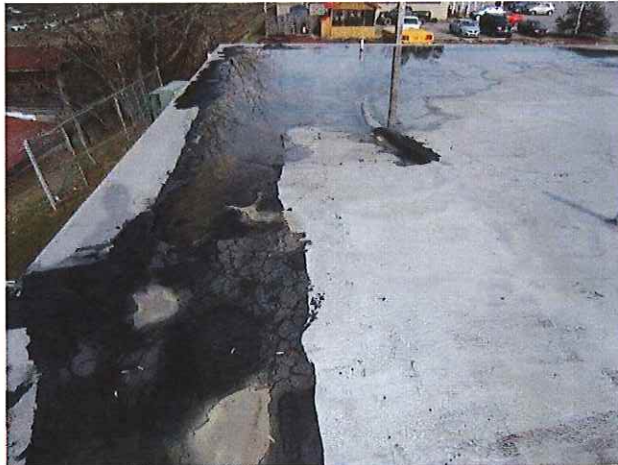
Photo 9: Overview of the lower roof perimeter and ponded water.

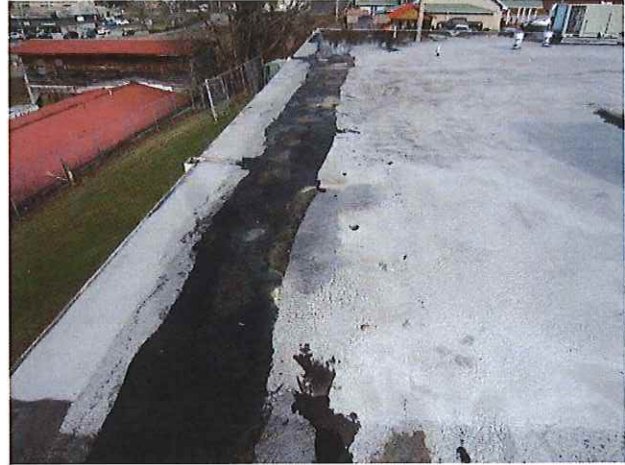
1. Shattering– N/A.
2. Open Laps – None observed.
3. Punctures – Minor. Three splits/tears were observed in the membrane.
4. Delamination – None observed.
5. Previous Repairs – Extensive. Sealant and emulsion coating have been applied at several locations on the BUR membrane.
6. Stripping Plies – Fair.

Photo 10: Overview of the building perimeter. Note large repair made with mastic.

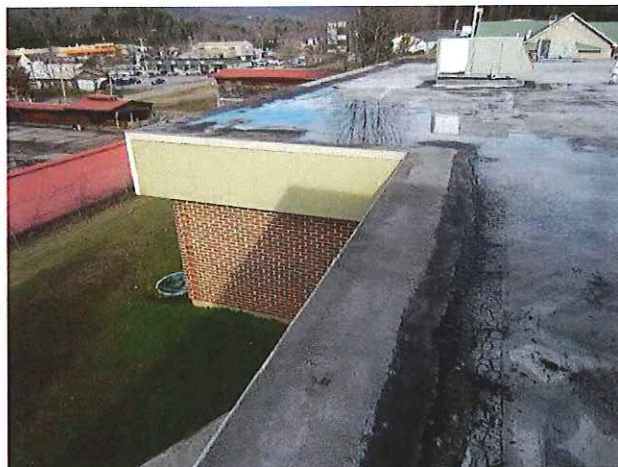
Photo 11: Overview of the lower roof perimeter. Note ponded water.

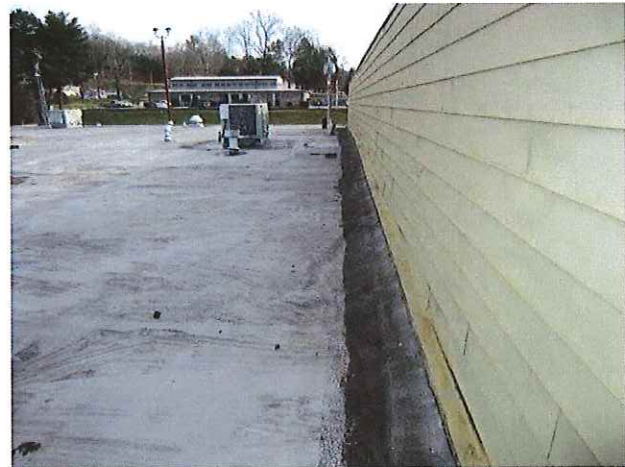
Photo 12: Overview of the lower roof at the junction of the higher roof. Note wood siding.

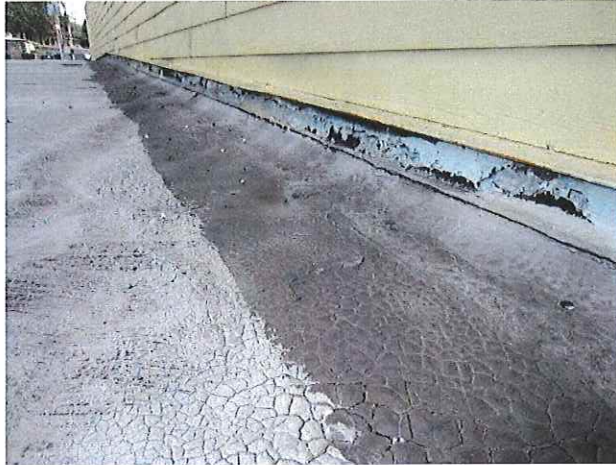
Photo 13: View of the termination of the base flashings at the junction to the high wall.

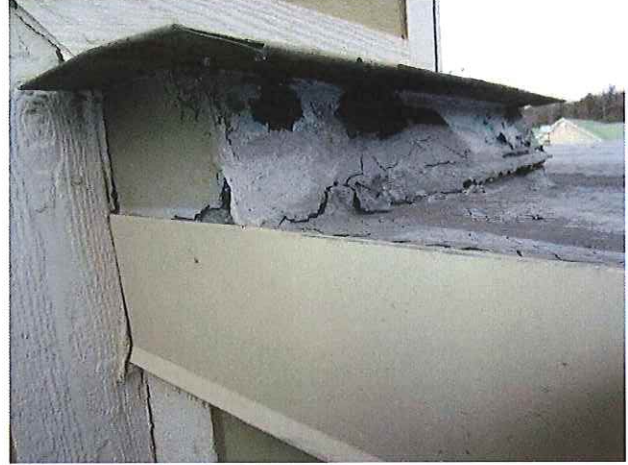
Photo 14: An additional view of the detail at the junction of the flashings termination.

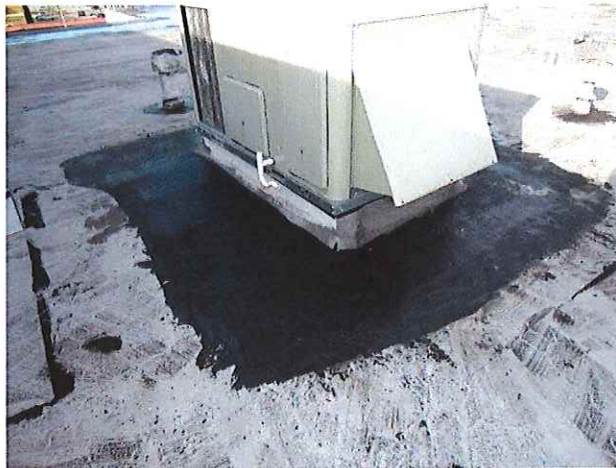
Photo 15: View of repairs at the perimeter of an RTU.

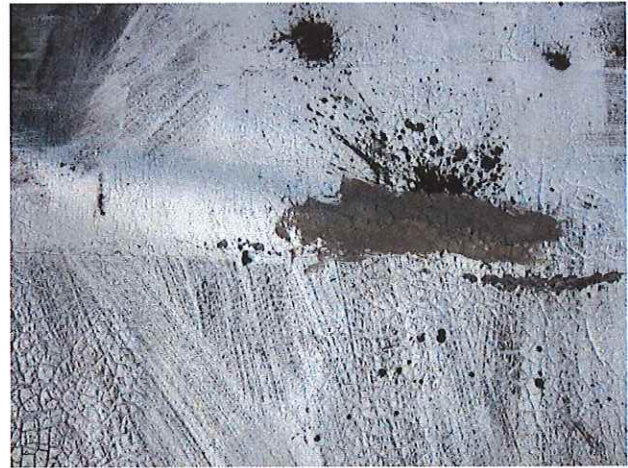
Photo 16: View of mastic repairs.

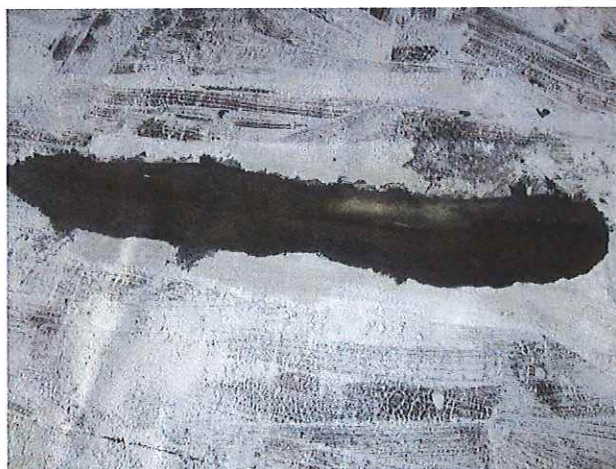
Photo 17: View of mastic repairs.

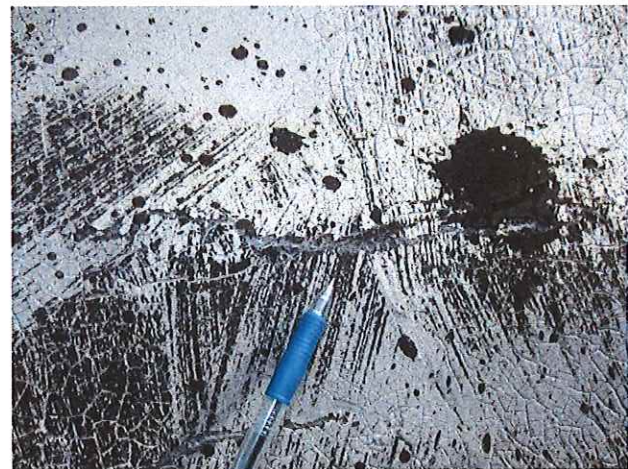
Photo 18: View of a split in the membrane.

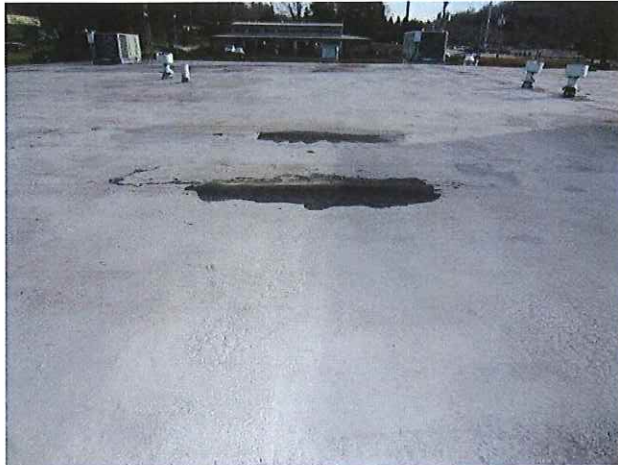
Photo 19: View of mastic repairs.

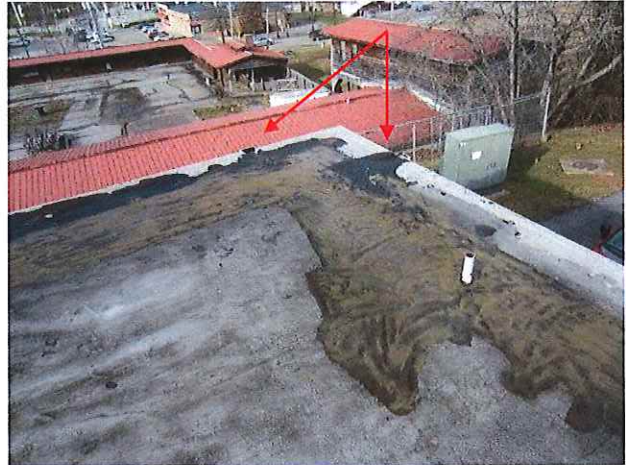
Photo 20: View of through edge scuppers.

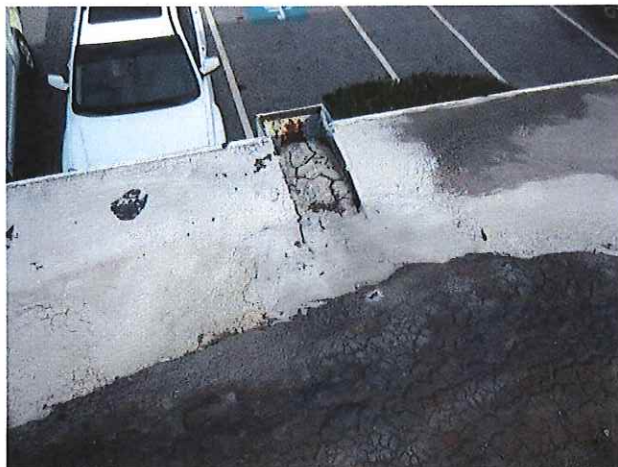
Photo 21: View of a through edge scupper.

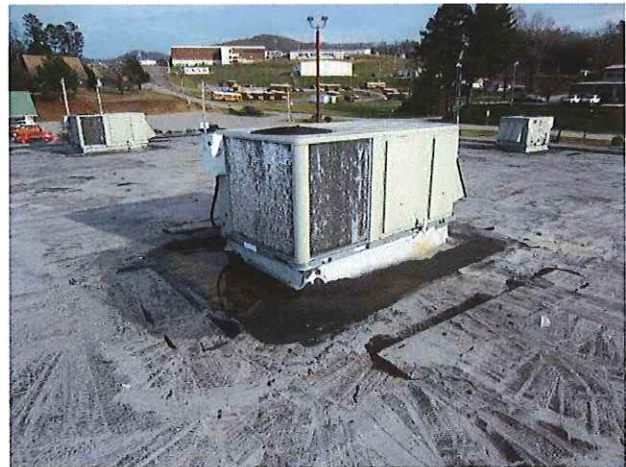
Photo 22: View of mechanical equipment.

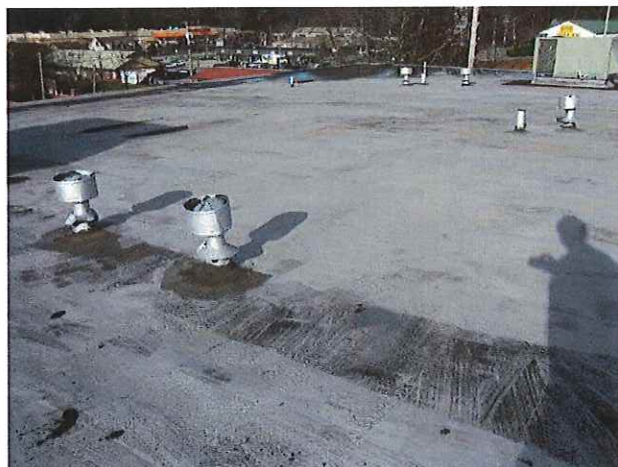
Photo 23: View of penetrations.

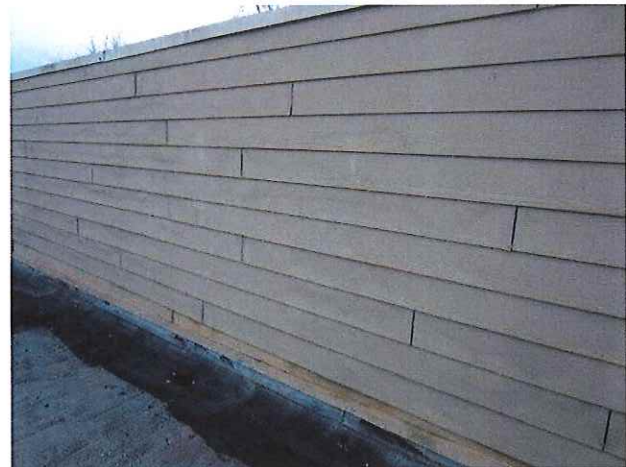
Photo 24: View of the wood siding. Note gaps at board joints.

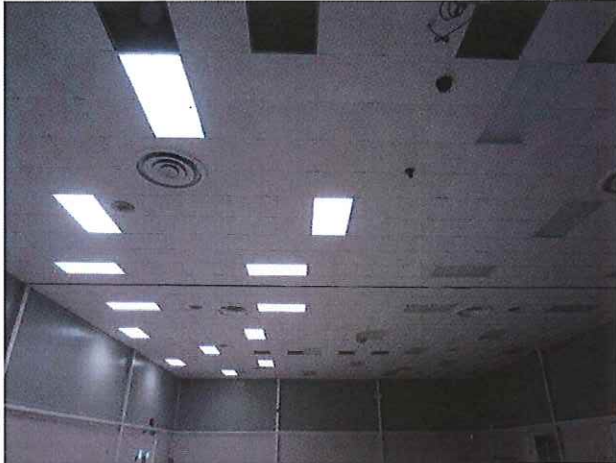
Photo 25: View of the suspended ceiling inside the building. This condition is typical.

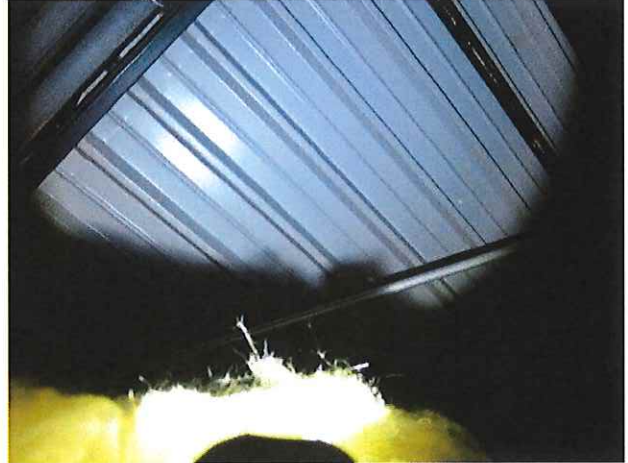
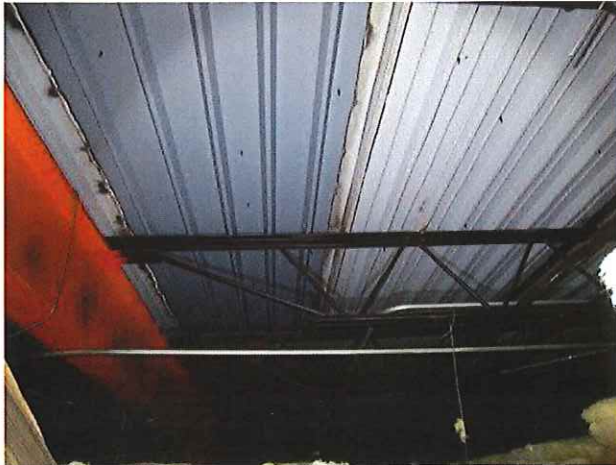
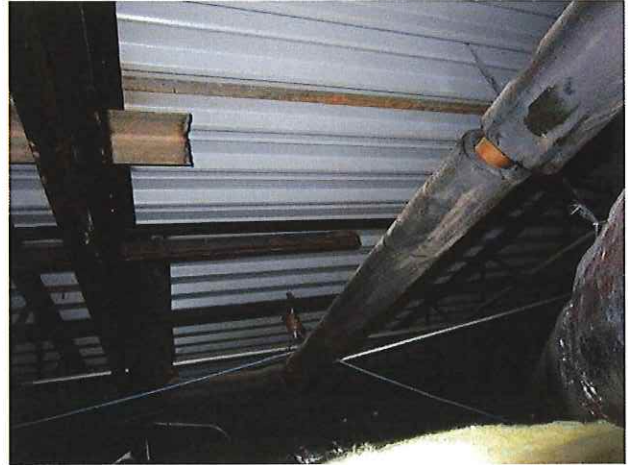
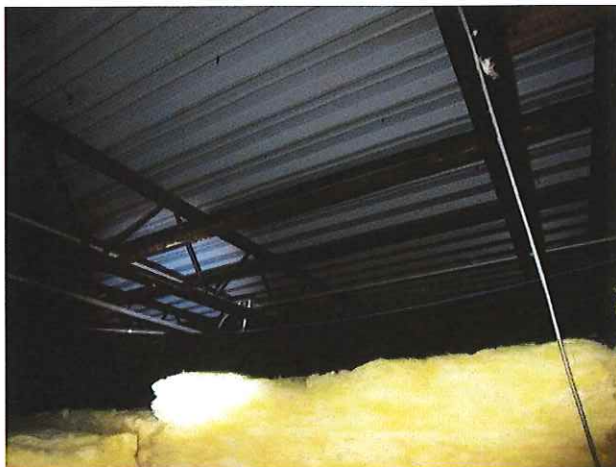
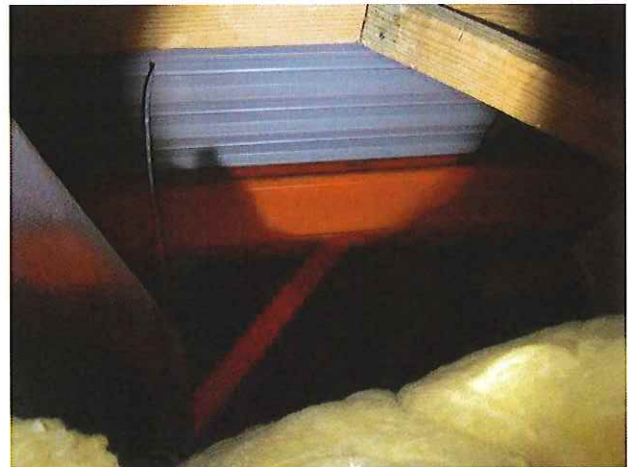
Photo 26: View of the bottom side of the deck.

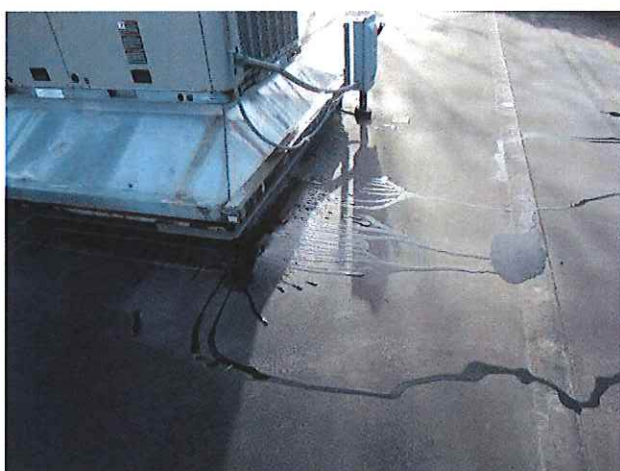
1. Debris – None observed.
2. Drainage – Fair to poor. The roof slopes to thru-edge scuppers at the three sides of the roof.
3. Physical Damage – None observed.
4. General Condition – Poor. The BUR has exceeded its useful life.
5. Equipment/Alterations – Fair. Two RTU's on the lower roof have ice on the condensing units and two RTU's on the EPDM roof are leaking from the base of the units.

Photo 35: View of leaking RTU's.

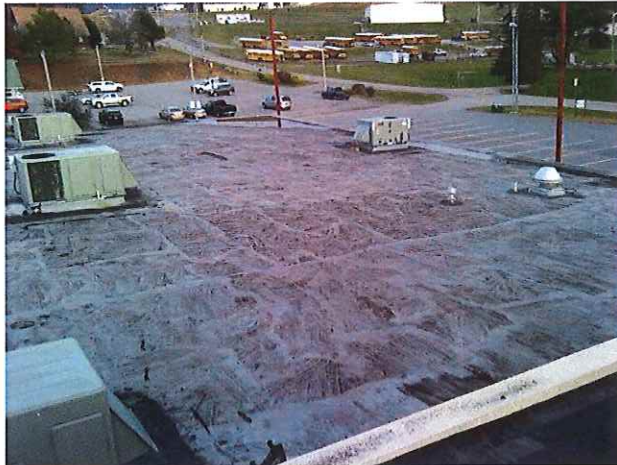
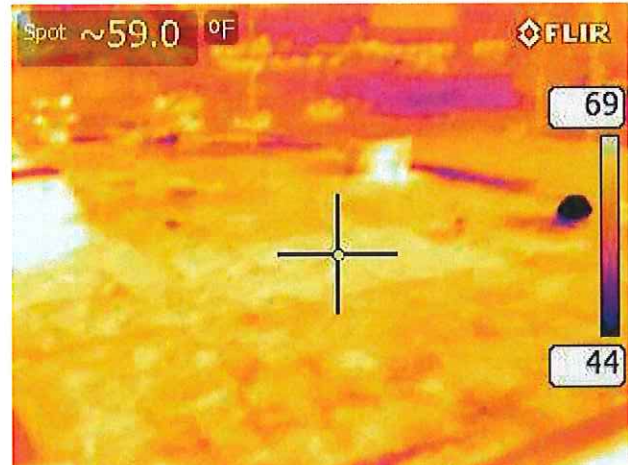
A Moisture survey was conducted using a Flir E60 infrared camera. The survey was conducted after the sun was no longer shining on the roof surface. The ambient temperature during the survey was 61 degrees F. Minor traces of moisture was detected in the BUR system by the IR camera. Photos 37-42 show conditions on the lower roof.

Photo 37: Digital view of the lower built up roof.

Photo 38: IR view of the previous photo.

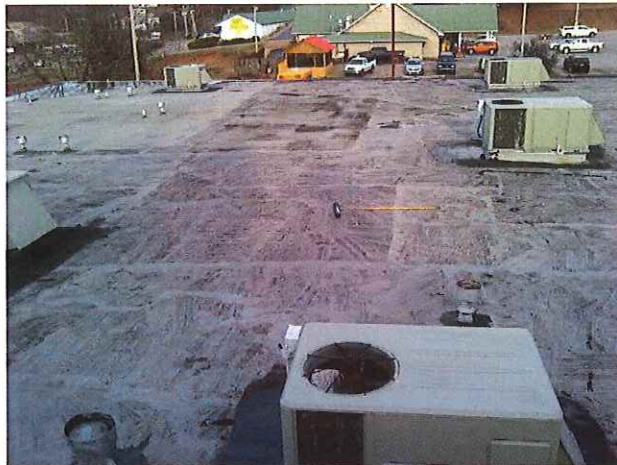
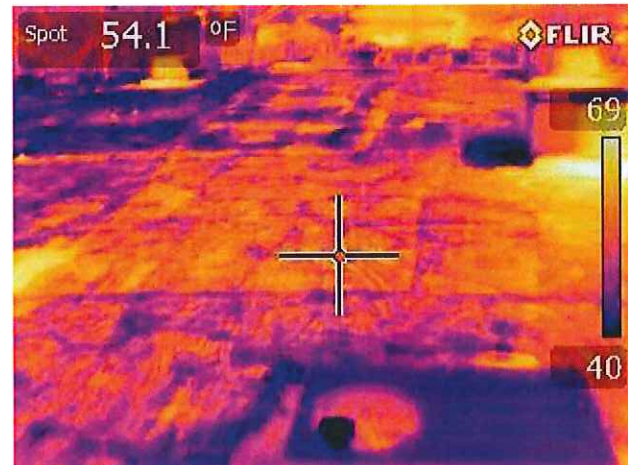
Photo 39: Digital view of the lower built up roof.

Photo 40: IR view of the previous photo.

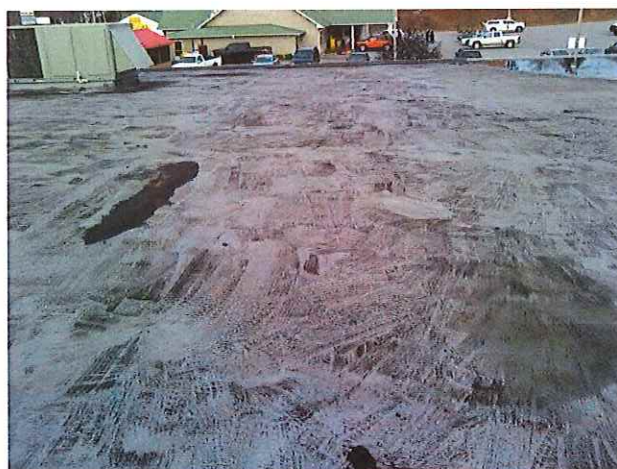
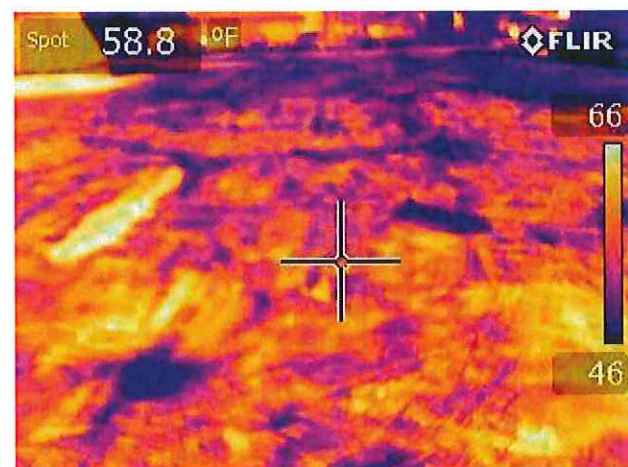
Photo 41: Digital view of the built up roof.

Photo 42: IR view of the previous photo.

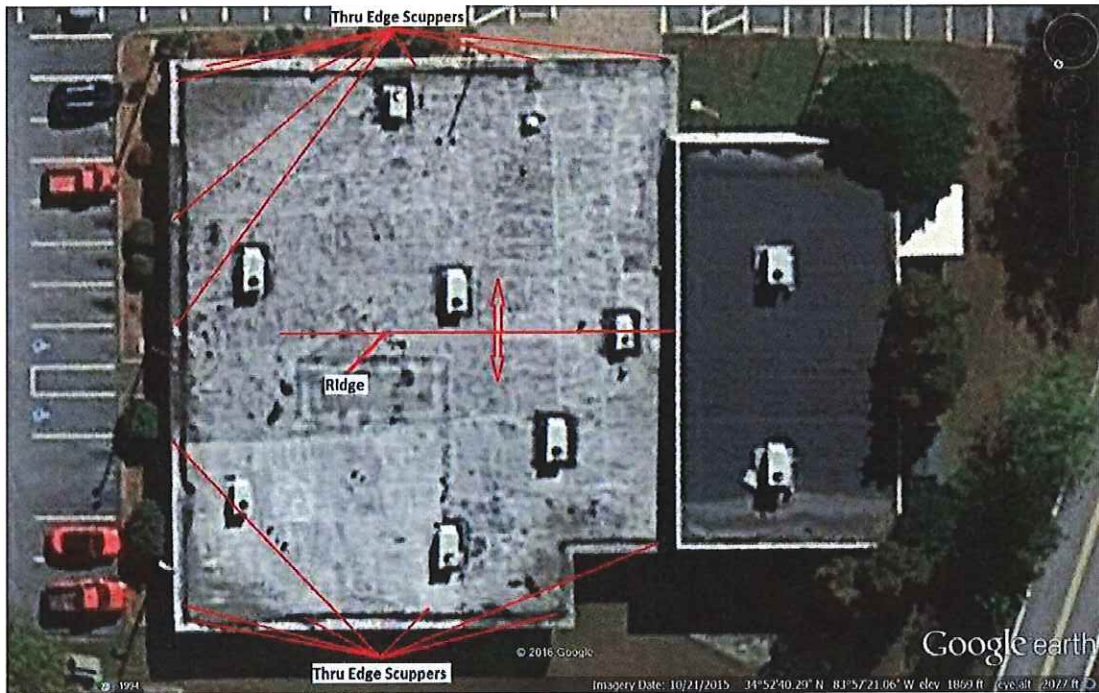
Arial Roof Image 10/21/15  
Union County Civic Center  
165 Wellborn Street  
Blairsville, Georgia 30512

There is a noticeable ridge on the roof extending from the high parapet wall to approximately  $\frac{3}{4}$  of the roof. The roof slopes toward the perimeter. Based on the location of thru edge scuppers, there may be a hip design in the structure. See the aerial image below.
